Rough Edges

Although far more common than they once were, pools with vanishing edges are still among the watershaping industry's most distinctive designs. Their increased popularity, however, has been accompanied by a rash of expensive repairs and structural failures in the walls used to create the edge effects. To get to the bottom of this disturbing trend, engineer Ron Lacher has investigated the causes and, in this article, presents his recommendations for solutions.

By Ron L. Lacher

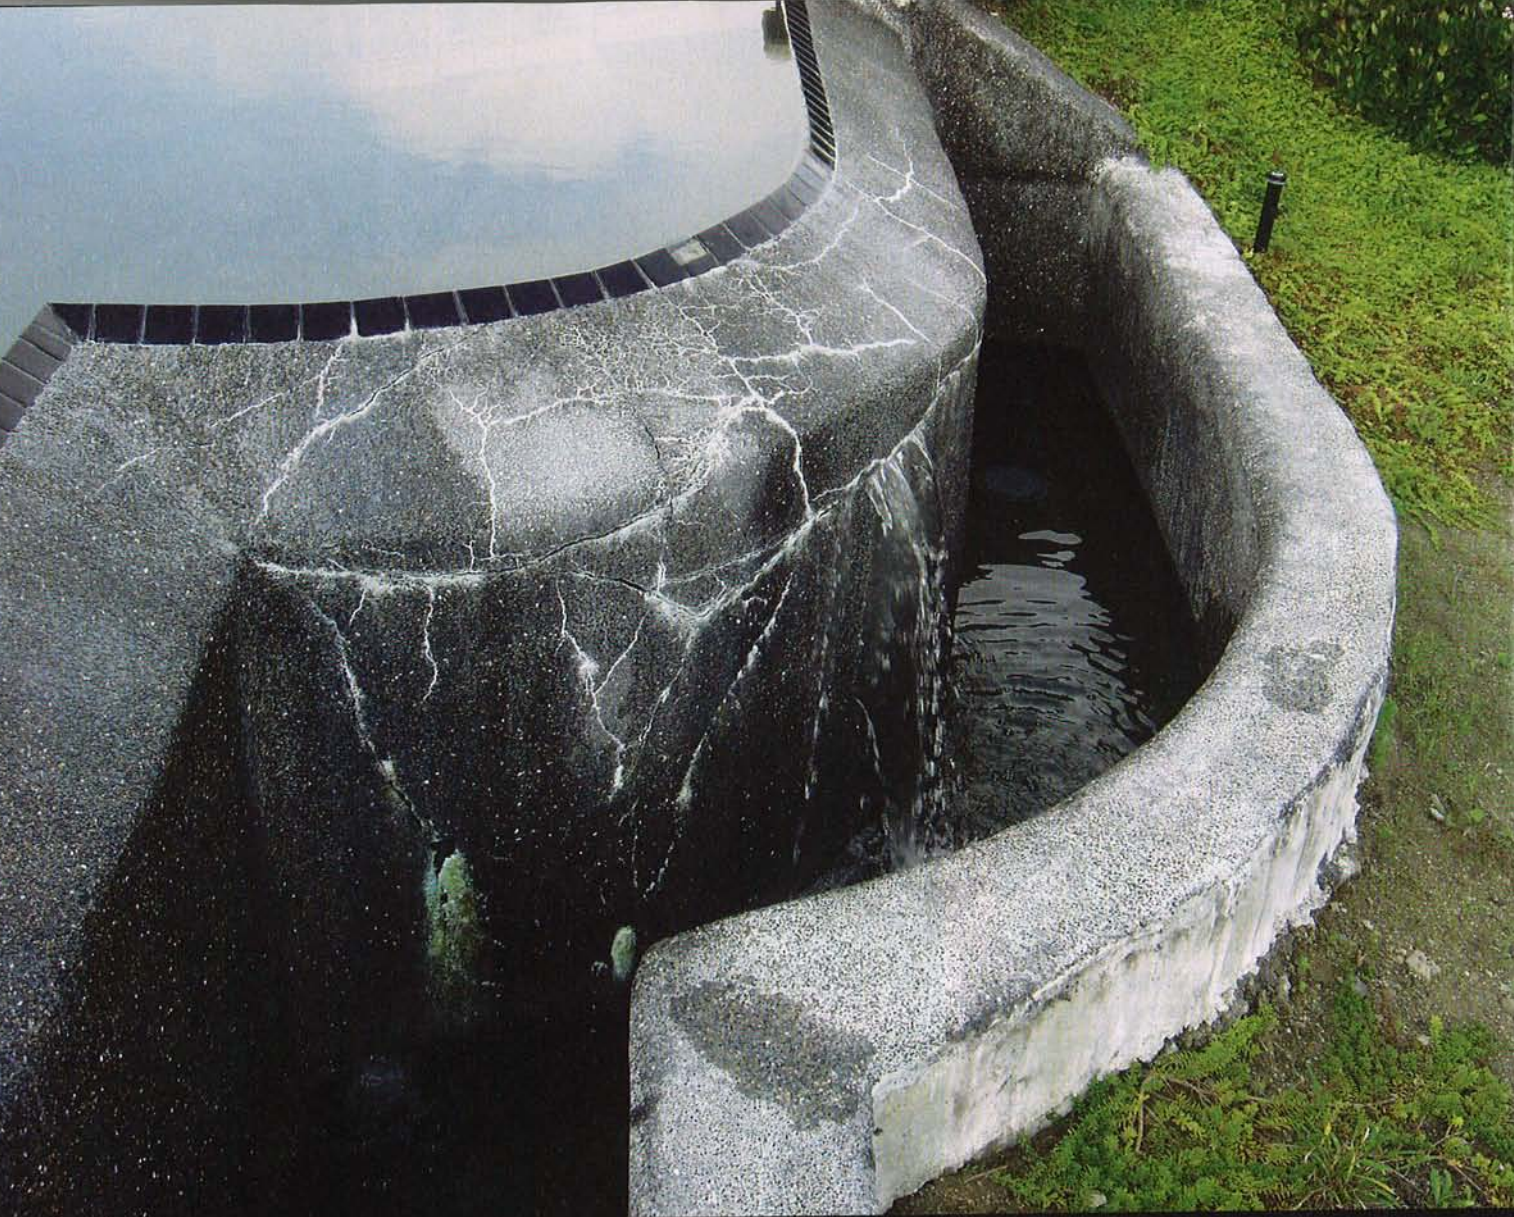
In the years since vanishing-edge pools gained incandescent popularity in the 1990s, we've seen more and more failures of the sorts depicted here, with extensive, disastrous cracking and delamination of surface materials. It took a while, but eventually patterns emerged that helped us determine why these freestanding weir walls were failing – and what needed to be done to prevent it.

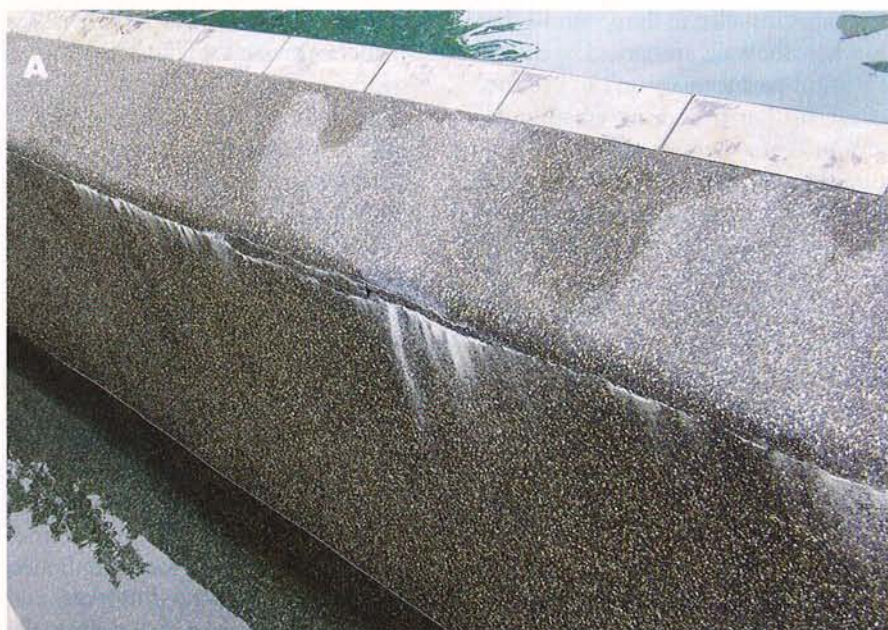
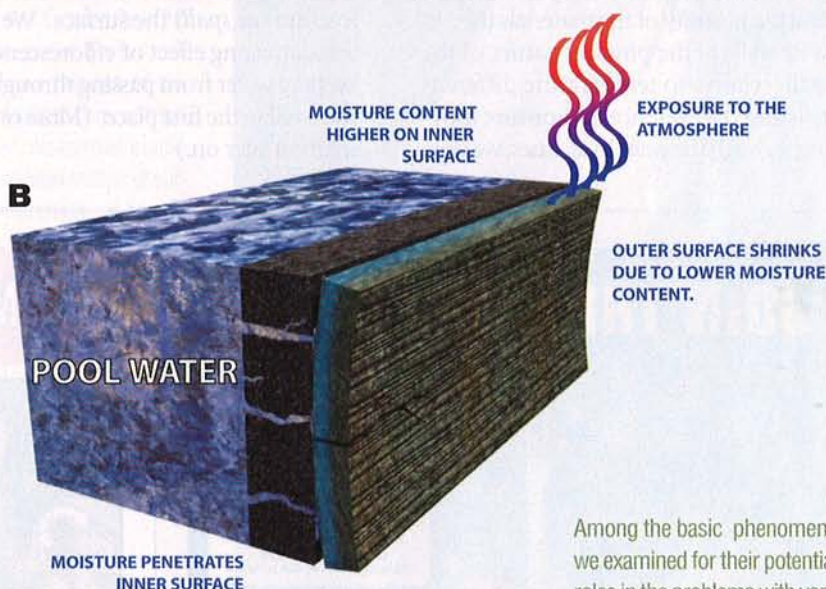
Among the basic phenomena we examined for their potential roles in the problems with vanishing-edge weir walls were efflorescence (A), which can build up and fracture the surface of a shell and cause cracking and delamination of surface materials, as well as curling (B) and warping (C), which have to do with unbalanced moisture exposure on the two sides of a concrete structure during the curing process. In all cases, the presence of these damaging factors can be traced to the passage of water from the pool through the semi-permeable membrane of a concrete shell.

Efflorescence is one such issue and is thought to be one of the primary factors in the cycle of weir-wall deterioration. Efflorescence is the simple formation of salt crystals through the evaporation of salt-bearing water. As water passes through a semi-permeable weir wall, salts remaining from the cement's hydration process are dissolved and carried by water as it moves through the structure.

Upon reaching the surface, the water evaporates and leaves behind the minerals – and thereby the evidence of water's transmission through the semi-permeable weir wall. As this process continues, salt crystals can build up in the pores and voids in the material and can eventually fracture (or *spall*) the surface. We stop this damaging effect of efflorescence by keeping water from passing through the weir wall in the first place. (More on this solution later on.)

One consequence of exposing concrete surfaces to environmental conditions is the phenomenon known as “curling.” More commonly an issue with concrete flatwork, curling happens when there are differences in the moisture level between the top and bottom of a concrete slab.

We all know that concrete shrinks as it dries and expands when moist. If you have a four-inch-thick concrete slab, for example, and the top surface is exposed to the atmosphere while the bottom is exposed to a moist subgrade, the top will dry faster than the bottom and the difference in the rate of shrinkage will cause the structure's shape to distort with its ends “curling” upward.

This same phenomenon can cause problems with the surface material on vanishing-edge weir walls when the back of the surface material is exposed to moisture penetrating the weir wall as the wall's front surface is exposed to the air. The stresses from curling can be tremendous and will expose any weakness of the bond between the surface material and the gunite or shotcrete substrate.

Another phenomenon is known as "warping," which is similar to curling but relates to concrete's expansion in response to heat. Basically, when one side is exposed to heat – as in the case of the outside surface material on a weir wall – the outside part of the material expands relative to the inside of the material and bows upward in the center.

The possible result of curling or warping is delamination or cracking in the surface material. When even a single crack forms as a result, efflorescence can begin to build up and the cycle of wall deterioration accelerates. To minimize this potential for delamination, we must use the highest-quality materials and follow established procedures to ensure that bonding strengths of surface materials to their substrates far exceeds the stresses placed on them by curling or warping.

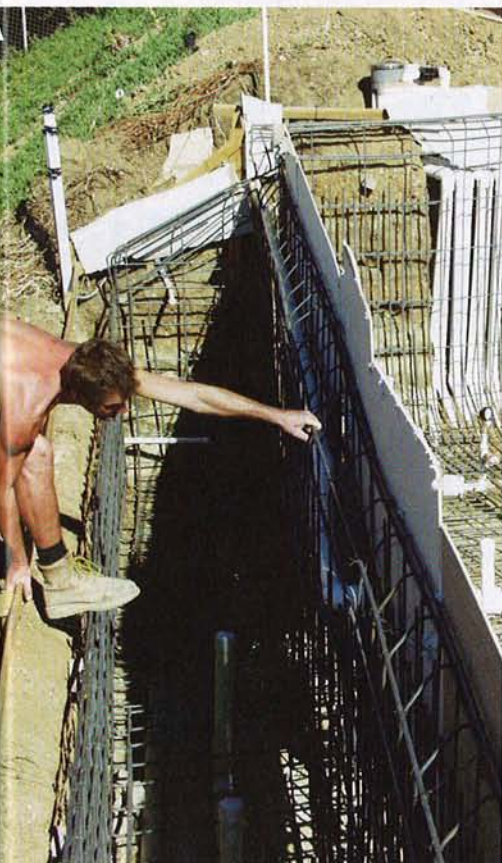
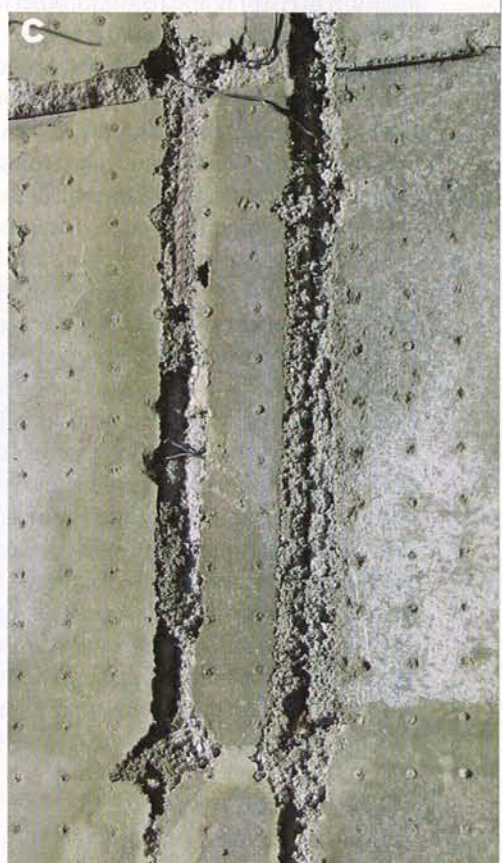
Workmanship plays a definite role in these problems with weir walls. Situations in which cages are inadequately secured and are able to move during shotcrete application are trouble (A), for example, as are instances in which no spacers are used to make certain rebar can be fully and completely encapsulated in concrete (B). The consequences in the latter case show up as soon as the forms are stripped (C) – and the situation only gets worse when water is introduced.

In the case of weir walls, I'm not exaggerating to say that violations of this standard are commonplace. All too often, I see crews install forms by tying them directly to the rebar with no spacers or dobies at all between the rebar and the form. What this means is that the rebar is, in effect, going to end up at or just below the surface of the concrete and will not be fully and completely encased.

With failed surfaces, the removal of the surface material often reveals structures in which the rebar is right there, visible on the gunite or shotcrete surface and without the required coverage.

Given this practice, there's little wonder why so many walls are failing: The rebar simply isn't properly encased in concrete! The good news is, the fix is obvious: Build stable rebar cages, tie them together properly, construct sta-

ble forms properly braced at the top and bottom and, above all, use spacers or dobies that allow proper coverage of the reinforcing steel.

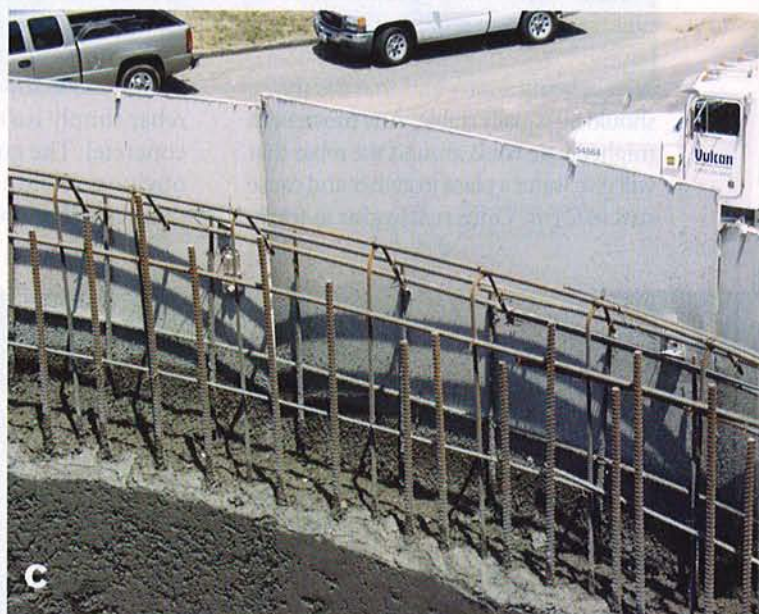
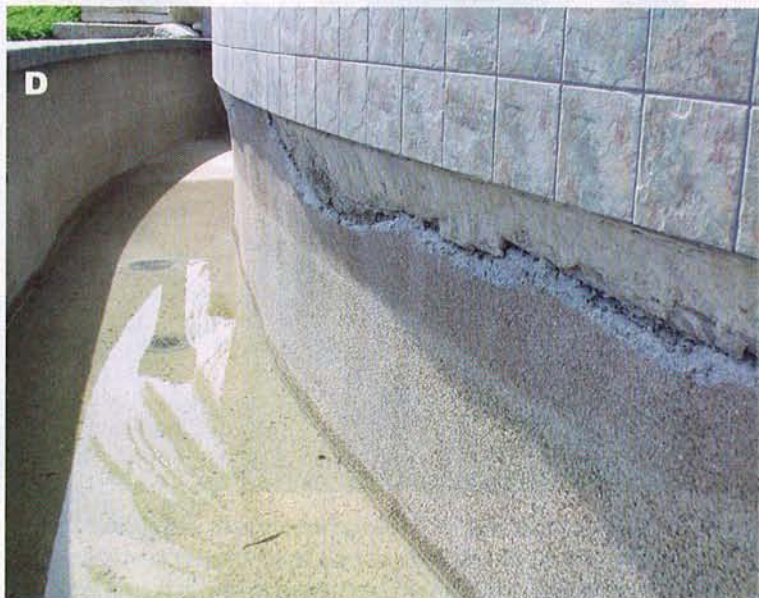
I recently visited a project that had a vanishing-edge pool as well as a separate vanishing-edge spa. The spa had an all-tile interior, so it had been thoroughly waterproofed, but the owner hadn't wanted to go to the extra expense of waterproofing the weir wall as well. Here, where the same exact materials and installation techniques had been applied to both weir-wall surfaces, the wall that hadn't been waterproofed soon showed signs of water penetration and a buildup of efflorescence, while the waterproofed weir wall of the spa is still pristine.

In addition to basic practices that should be applied anyway, weir walls must also be given the added protection of some form of waterproofing – at least on the inside but preferably on both the inside and outside surfaces. If the above workmanship standards are observed, the added layer of protection afforded by

proper waterproofing should be enough to keep these exposed walls from failing.

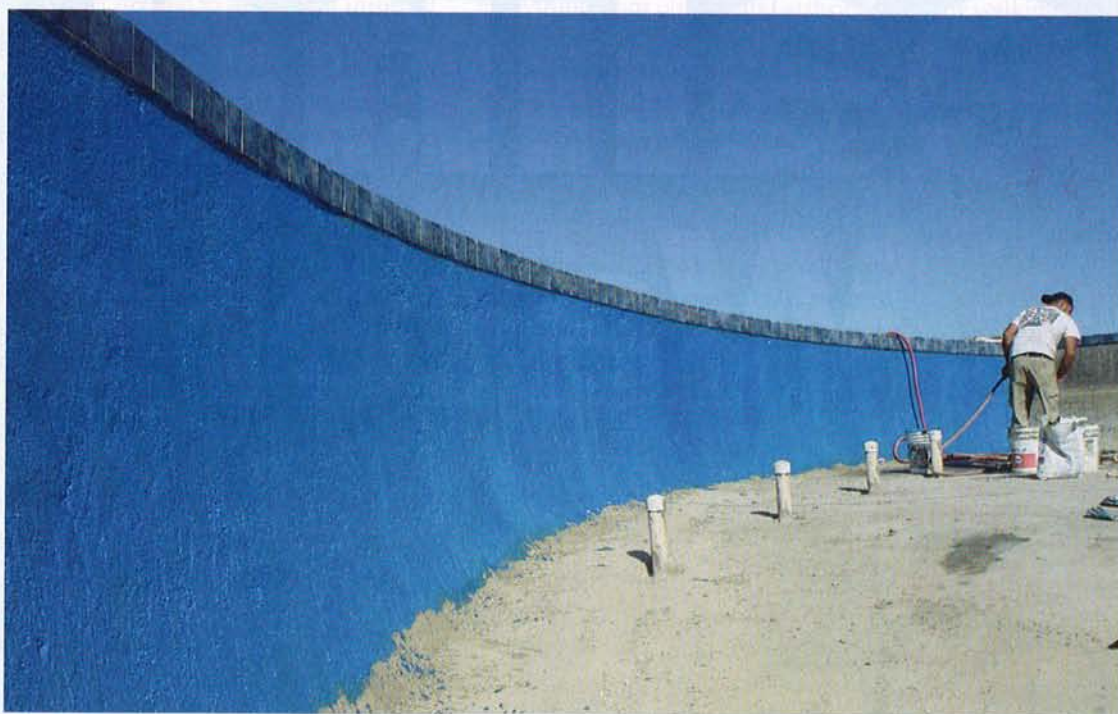
Waterproofing is a good idea on both sides of a vanishing-edge weir wall, simply because, when properly applied according to manufacturer instructions, these coatings minimize the transfer of water from the pool to the outside of the wall and thereby act as welcome layers of protection.
