## Rubble from Rebound

Eric Herman  
Apr 21, 2022

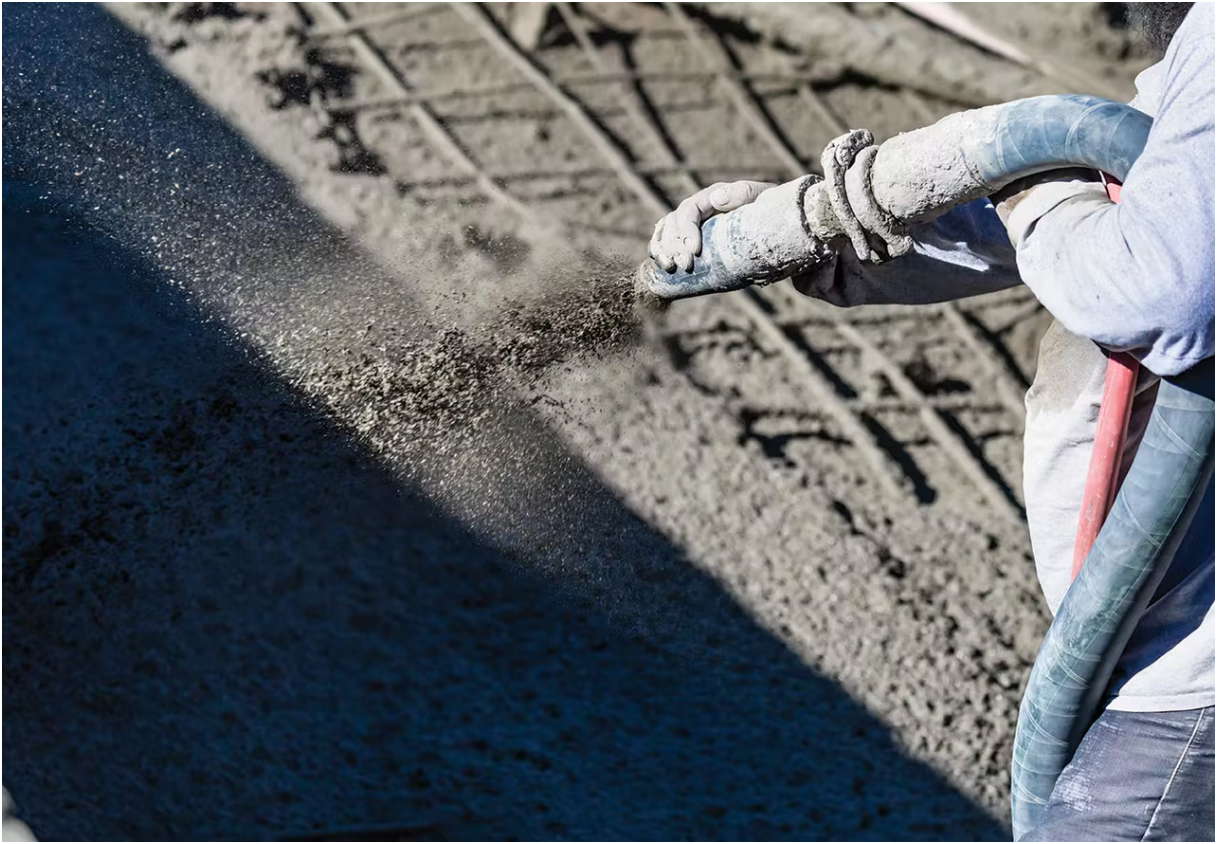
The use of "shovelcrete" (gunite rebound) has declined in recent decades due to rising professionalism among builders. It remains a hidden practice for some companies.

When a renovation contractor inspected the spa and opened up the steps to see what was going on, the problem became immediately apparent. The steps and benches appear to have been packed with rebound during the initial installation more than two decades ago. Upon inspecting other parts of the pool, the rest of the shell appeared sound, and was not showing any signs of cracking. When the spa did finally crack, water intruded and it was game over for that part of the structure.

the installation. The problem being, of course, when shotcrete is not actually “shot” into place, it has no structural strength and doesn’t even technically qualify as concrete.
